## **“STILL LATCHED-UP AFTER ALL THESE YEARS - MORE CLUES IN THE 7-SERIES FPGA MICRO-LATCHUP MYSTERY”**

Presented at:  
SEE Symposium, Oct. 7, 2020

Authors: David Russell, David Vail, Daniel Fiers, Joseph Sackman, Steven Burg and Cody Dinkins (L3-Harris)  
Gary Swift (Swift Engineering & Radiation Services)

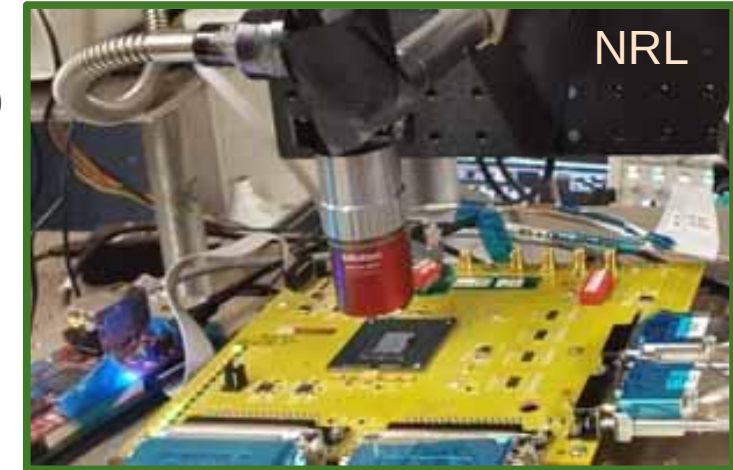
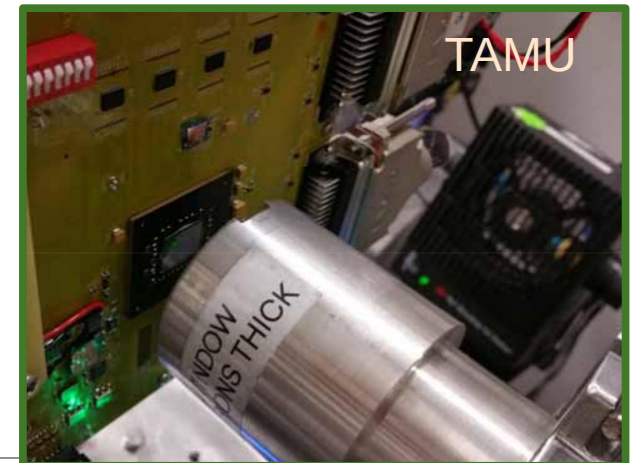
- net area coverage < 0.1%, maybe 0.01%
  - Heavy Ions Testing with Masking at TAMU in July 2015
    - Success! Localized sites to approx. two sq.mm near one corner- nowhere else

- Maintained latchup in eight sites on six DUTs with batteries for further study

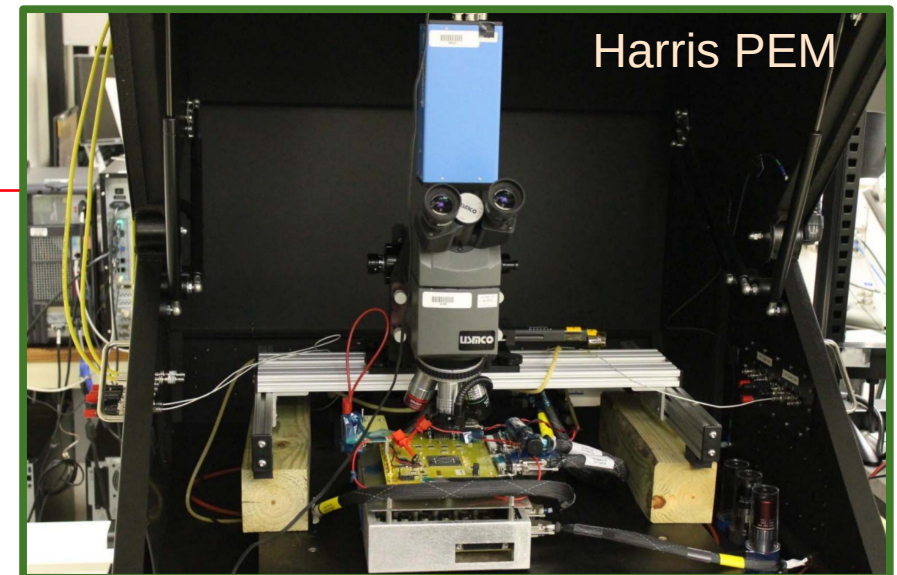
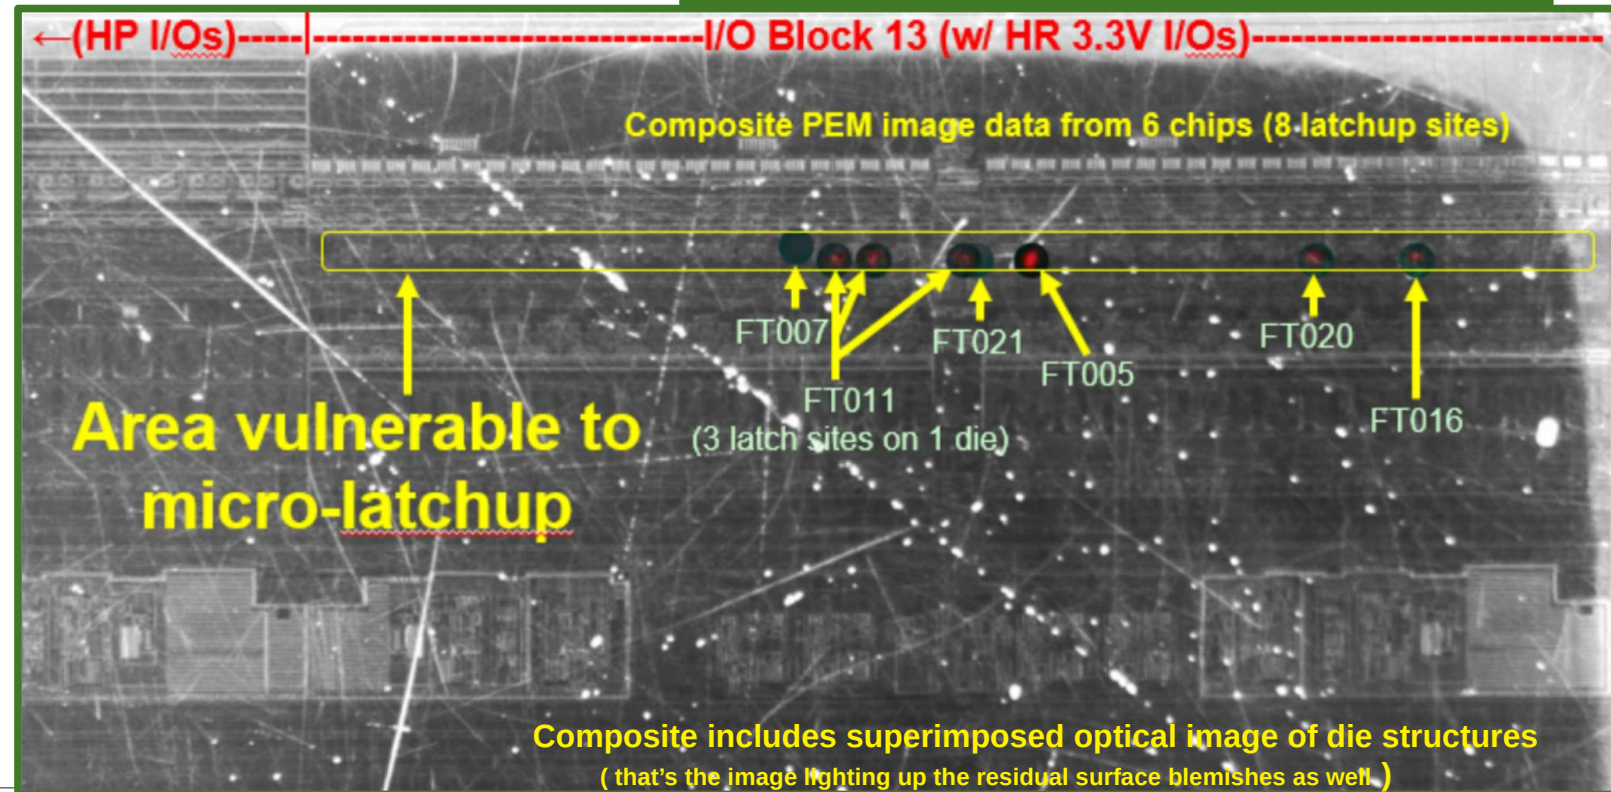
- HURRAY!
- The “Smoking Gun” found in the Harris FA lab in Florida.
- Photon Emission Microscopy (PEM) imaging reveals sites are:
  - Only in HR “high range” I/O’s
    - HR level shifter max: 3.3V
  - NOT in HP “high performance” I/O’s
    - HP max: 1.8V
- IMPORTANT NOTE:
  - Steps in 1.8V Vaux, not I/O 3.3V rail
- Backstory (2015) CONCLUSION:
  - It should be easy to find HR I/O functional problem(s) induced by the  $\mu$ SEL sites → suspect level shifter
    - Proof postponed
    - Not so easy, as it turns out

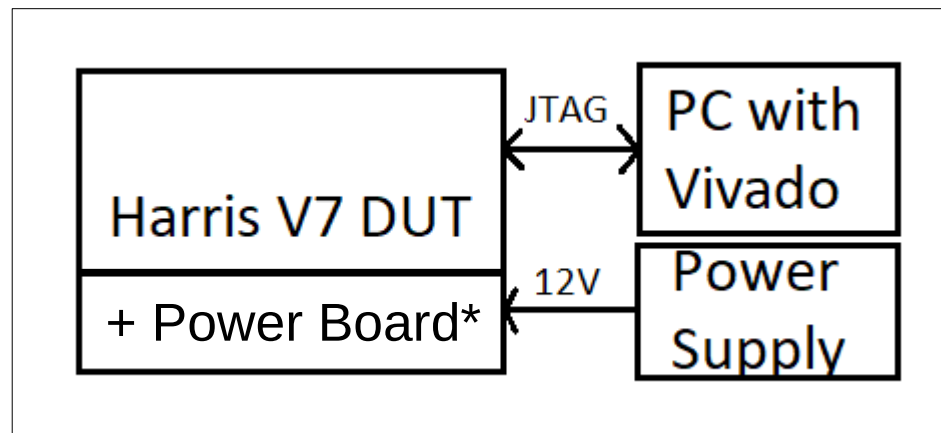
- Two unirradiated (control) DUTs  $V_{ccaux}$  rail currents:
  - Nominal: between 75 & 100mA
  - Expected 75mA per Xilinx\*\*
- Three DUTs still exhibit  $\mu$ SEL currents (as of Feb. 2020):
  - FT016 – 172mA
  - FT021 – 188mA
  - FT007 - 200mA
- Two (formerly) latched-up DUTs also exhibited nominal current draws on  $V_{ccaux}$  when re-powered, as expected

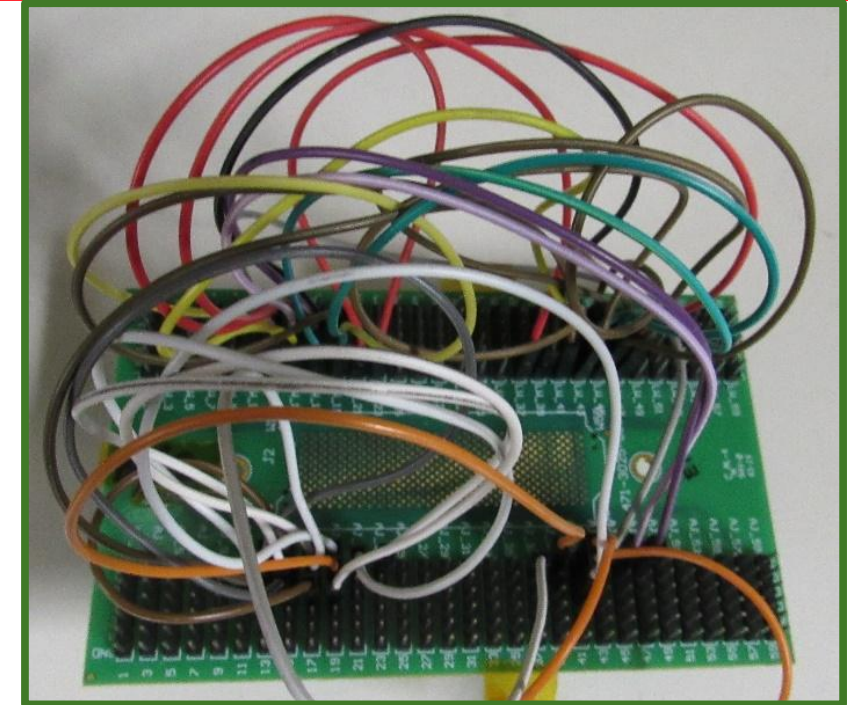
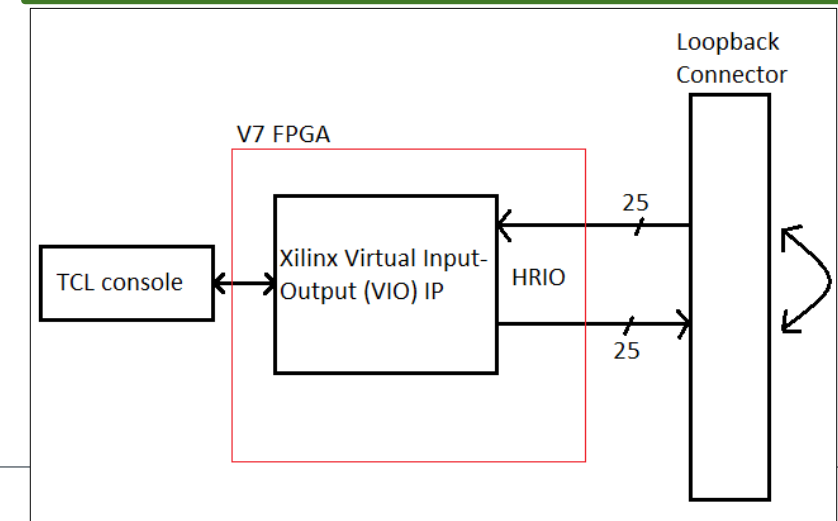
- Hypothesis #1: Level shifter malfunction
- REFINEMENT of Hypothesis #1
- Affected pin would work as input, but stuck as output
  - from Austin Lesea, Xilinx R&D Sr. Principal Engineer
  - Based on scrutiny of circuits and layout, proprietary details
  - Hypothesis is easily tested with the loopbacks
- Test setup: loopback wires on XRTC breakout board
  - Design: 25 HR pins as outputs to other 25 as inputs
    - Testing all HR's to try to identify one with  $\mu$ SEL
  - Reverse Design: outputs and inputs swapped
  - I/O standard: 3.3V LVCMOS uses “full” level shifter
  - TCL script toggles outputs one-by-one, reporting any errors
- Results: Hypothesis #1 WRONG
  - DUTs in  $\mu$ SEL, all three: PASS
  - Controls, four unirradiated + two formerly latched: PASS
  - Control, unirradiated FT006: FAIL on one pin (AV30)

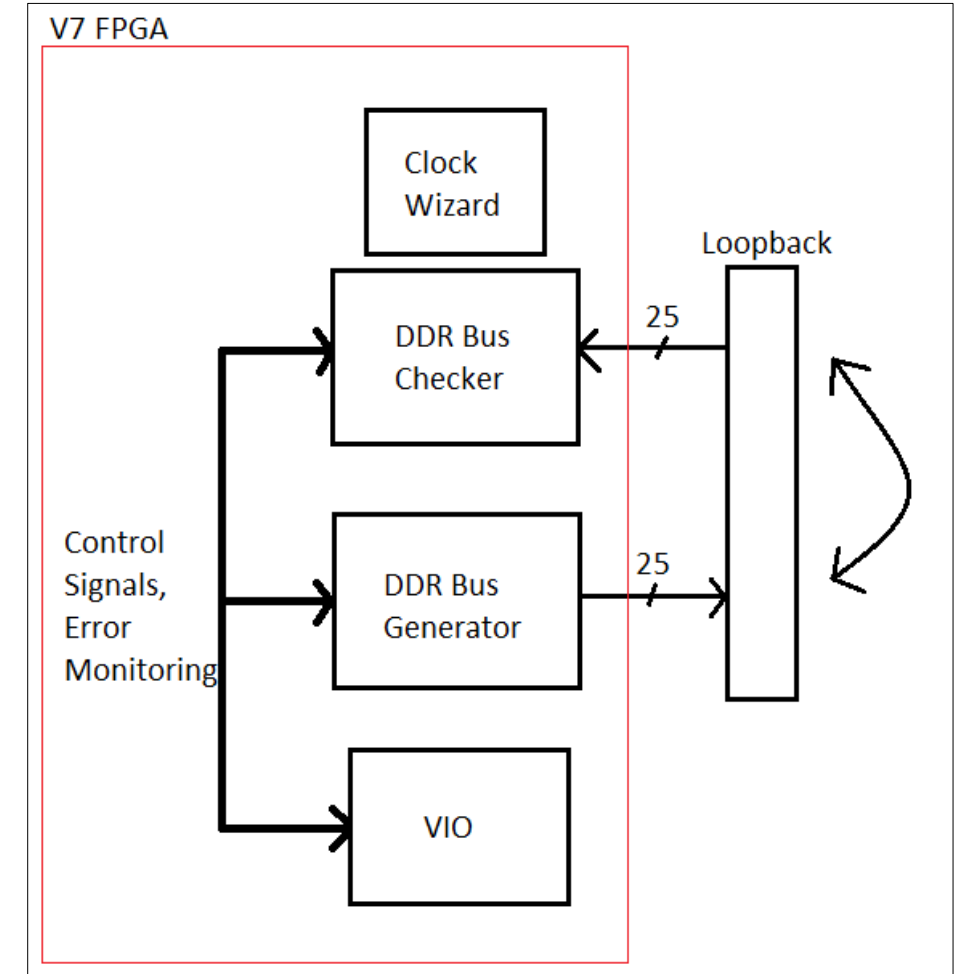
- Hypothesis #1A: Level shifter performance degradation from  $\mu$ SEL
- REFINEMENT
- Maximum operating frequency would be impacted by  $\mu$ SEL
- Test setup: slight mod of loopback setup (previous slide)
  - 24 bit loopback 'bus' as 2 pins are dedicated for clock & control
  - Again 3.3V LVCMOS I/Os, Forward and Reverse Designs
  - Generator/Checker IP patterns: 1) pseudorandom & 2) counter
  - Clock rates: 5, 10, 25, and 40 MHz (x2 using both clock edges)
- Results: Hypothesis #1A is probably WRONG
  - The three latched-up DUTs and three controls
    - Pseudorandom: PASS at 10 MHz and FAIL at 25 MHz
    - Counter Pattern: Pass at 25 MHz, FAIL at 40 MHz
  - Except one control FAIL at 25 MHz with the counter pattern
  - Fails are probably more about test fixture limitations than the FPGAs

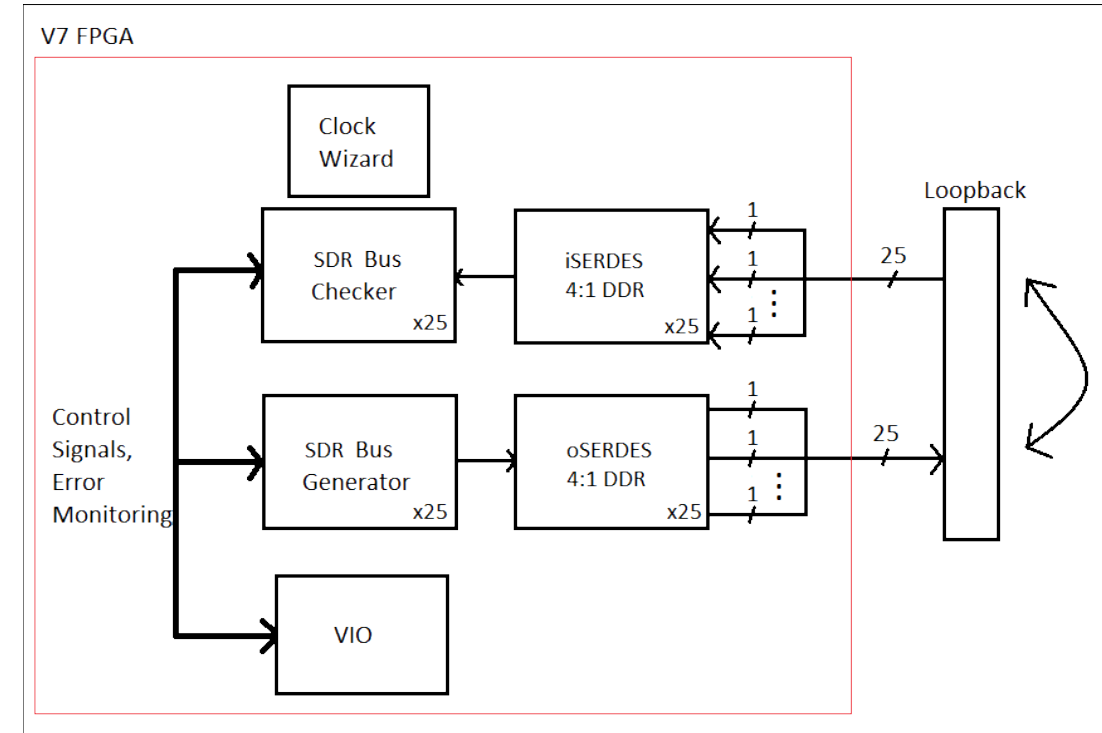
- Hypothesis #2: IOSERDES fail or degradation from  $\mu$ SEL
- REFINEMENT
- Maximum operating frequency would be impacted by  $\mu$ SEL
- Test setup: loopback setup (same as previous slide)
  - 24 bit loopback 'bus' as 2 pins are dedicated for clock & control
  - Again 3.3V LVCMOS I/Os, Forward and Reverse Designs
  - Generator/Checker IP patterns: 1) pseudorandom & 2) counter
  - Clock rates: 10, 20, and 40 MHz (x2 using both clock edges)
- Results: Hypothesis #2 is probably WRONG
  - The three latched-up DUTs and three controls
    - Both patterns: PASS at 20 MHz, FAIL at 40 MHz
  - Again, fails likely from test fixture limitations, not the FPGAs

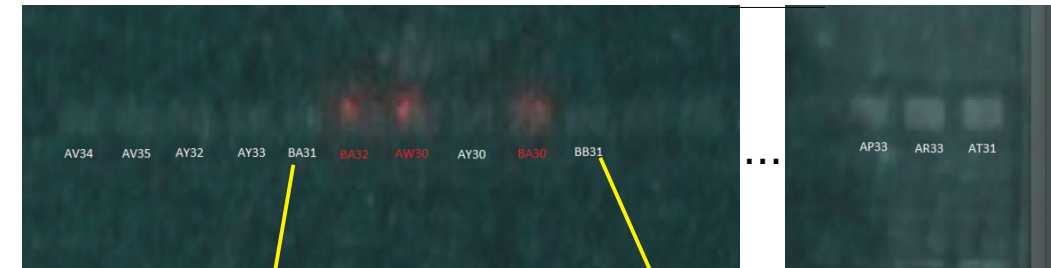
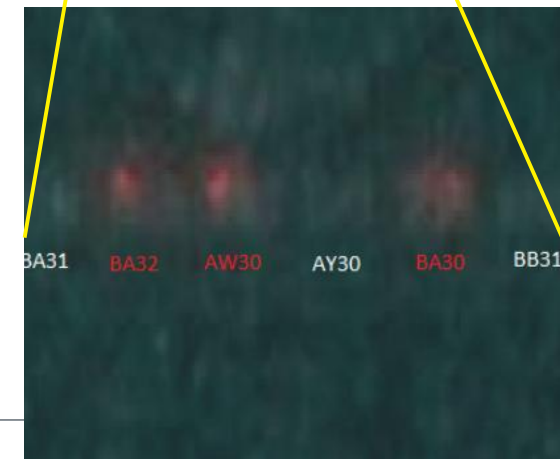
- Hypothesis #3: DC logic level degradation from  $\mu$ SEL
- Hypothesis #4: AC waveform degradation from  $\mu$ SEL
- Hypothesis #5: Level shift down degradation or fault
- Test setup: hook 'scope to outputs (instead of loopbacks)
  - Four pins checked- three suspects and one control
  - Suspects chosen mapping PEM sites for the 3 DUTs to pins → (reverse engineered map of red spots to pins may be wrong)
  - AC tests at 6 MHz
- Results: Hypothesis #3, #4, & #5 are WRONG (or pin map is wrong)
  - For all three latched-up DUTs, high and low levels measured for the selected pins are “in spec”
  - Toggling outputs looked identical on all four pins on all three latched-up DUTs (or differences are subtle)
  - Toggling 1.5V LVCMOS outputs had levels in spec and identical waveforms as well

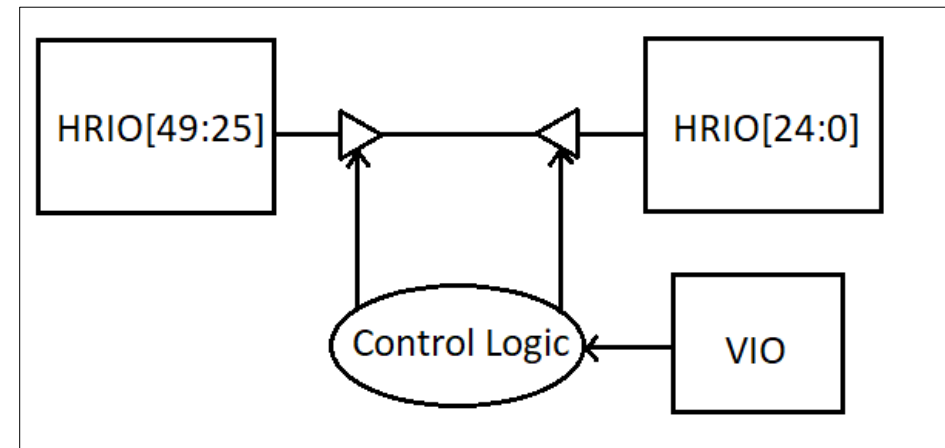
- Hypothesis #6: Tri-State Enable or Disable Failure
- ELABORATION
- Affected pin might not tri-state when signaled
- 
- Test design:
  - Toggle BANK Tri-State Enable
  - I/O Standard: 3.3V LVCMOS
  - Direction control added so no Reverse Design needed
- Results: Hypothesis #6 is WRONG
  - No functionality problems observed
